# TECHNICAL SERVICE BULLETIN

REF.: ENGINE  
NO.: EG003-96  
DATE: OCTOBER 11, 1996  
MODEL: ALL MODELS

## UNDERCOATING ON OXYGEN SENSORS

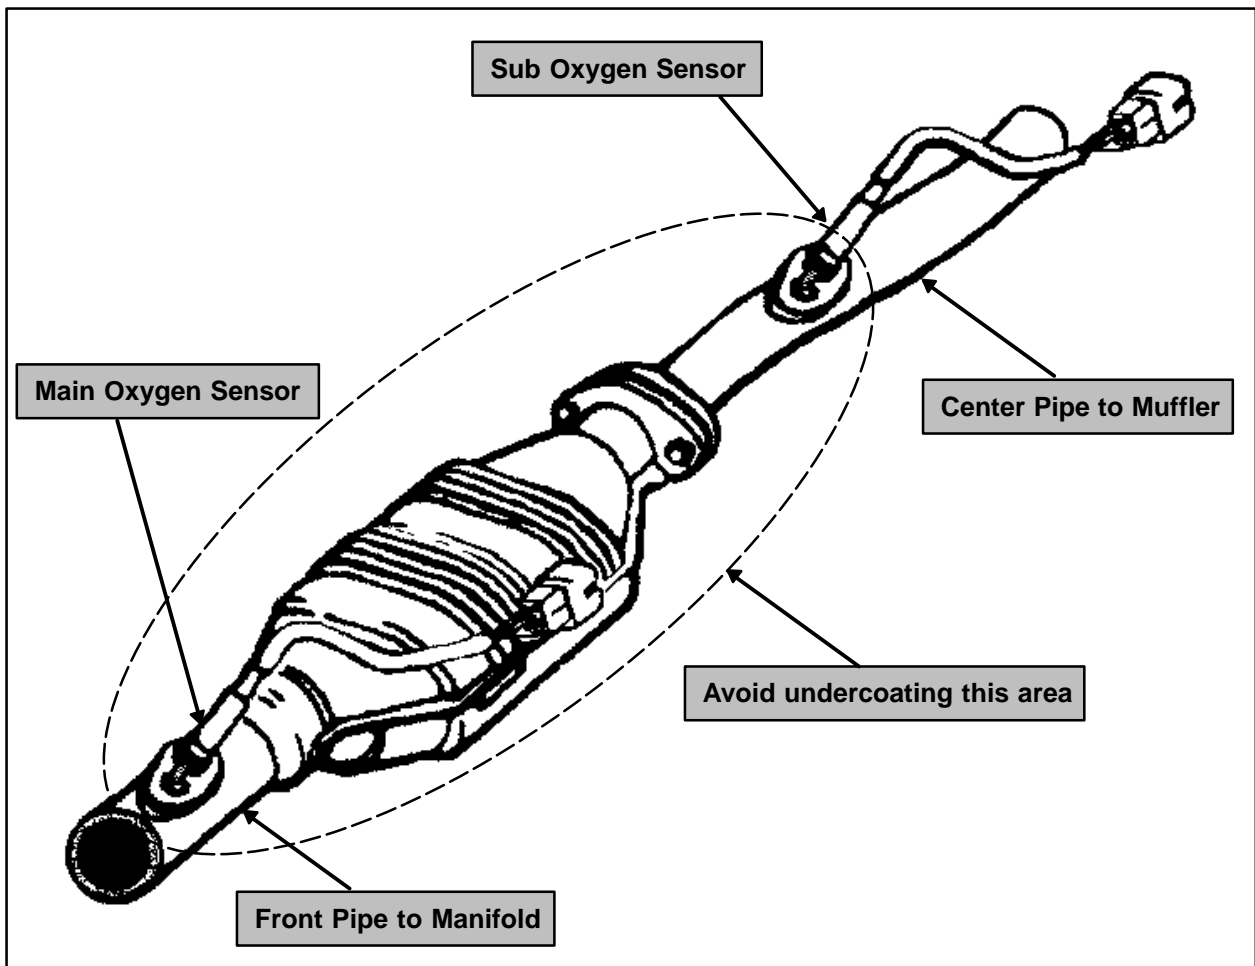
During vehicle processing by Dealers, care must be taken to avoid applying undercoating in the area surrounding the Oxygen Sensors. Application of undercoating on or near the Oxygen Sensors can cause insufficient air to flow around the sensor, and inaccurate information storage by the ECM. If this condition occurs, the Malfunction Indicator Light (MIL) may illuminate.
