**Technical Service
BULLETIN**

**REPAIR MANUAL SUPPLEMENT:
VEHICLE PULLING TO ONE SIDE**

All '02 – '06 Toyota & '04 – '06 Scion Models

REVISÉD
ST005-01
STEERING

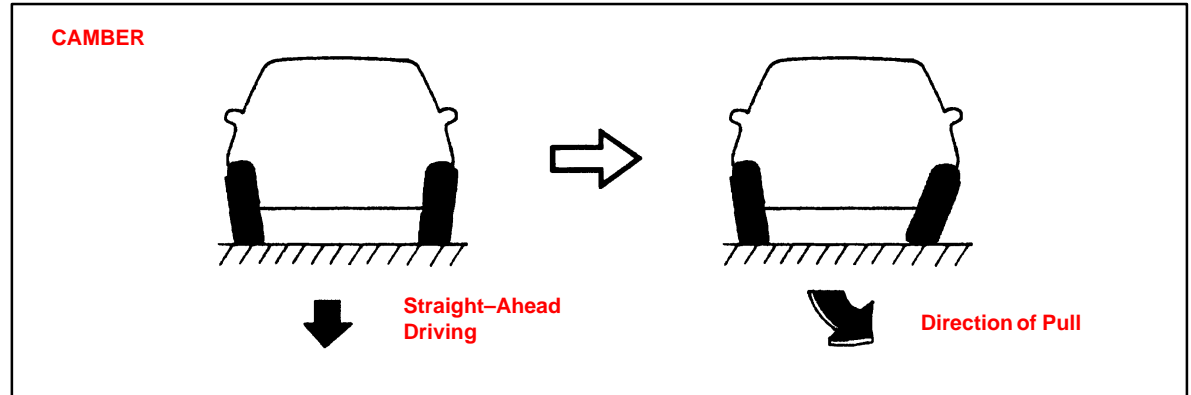
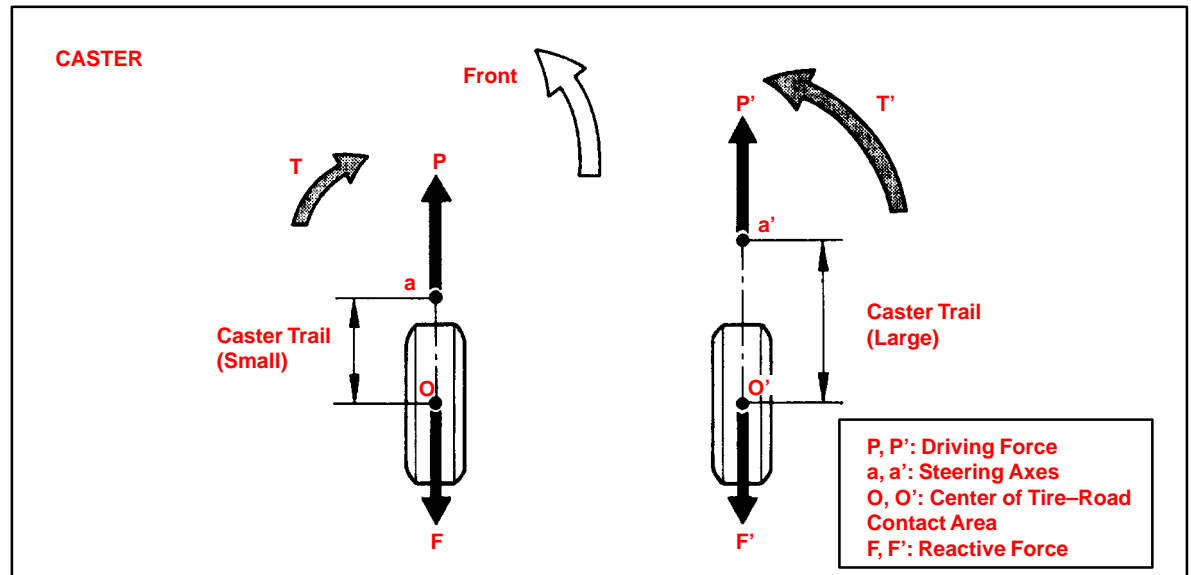
When the cross camber or caster of the front wheel alignment is large, it can cause vehicle pulling.

WHEEL ALIGNMENT	DIRECTION OF VEHICLE PULLING
Camber	Vehicle pulls in direction of wheel with large camber value
Caster	Vehicle pulls in direction of wheel with small caster value

If the cross camber or caster is within the specified range (30' or less), noticeable vehicle pulling will not occur due to side-to-side differences in camber or caster.

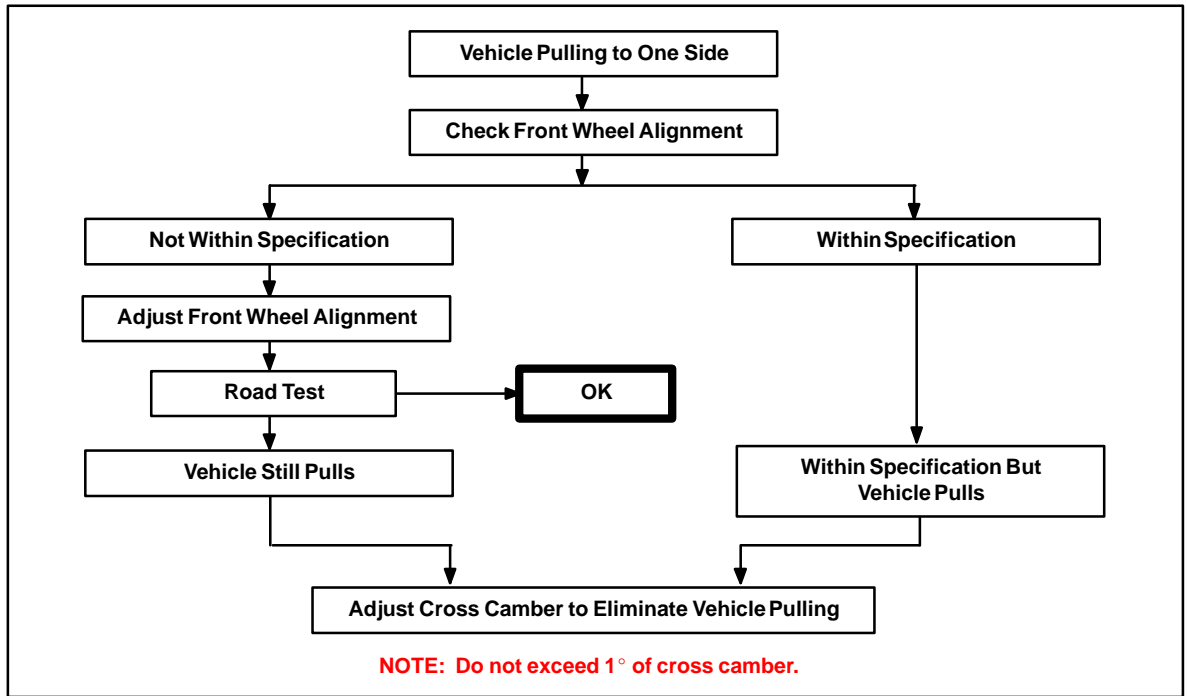
When it is determined by troubleshooting that the vehicle pulling to one side is caused by wheel alignment, perform repairs according to the following procedure.

WHEN VEHICLE PULLS TO LEFT	WHEN VEHICLE PULLS TO RIGHT
Increase right front camber and decrease left front camber until vehicle pulling is eliminated	Increase left front camber and decrease right front camber until vehicle pulling is eliminated

- Keep the cross camber within 1° or less.
- Keep the camber of each wheel within specifications (+/-45' of center value).
- If adjustment exceeds the specifications, uneven tire wear will result.

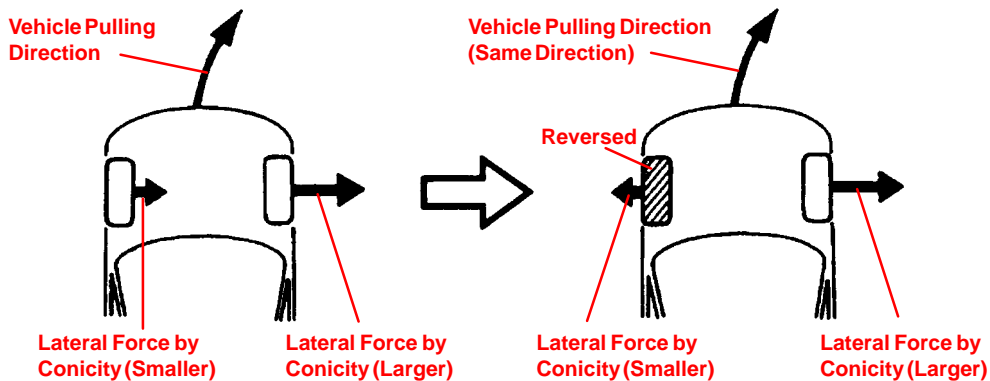
If Vehicle Pulls in the Same Direction: Go to STEP 2.

The lateral force generated by the right front tire is greater than the left tire, so the vehicle is pulling due to the lateral force of the right tire.

Remove the front left tire from the wheel and reverse the tire. Then perform a road test and check for change in the pulling direction.

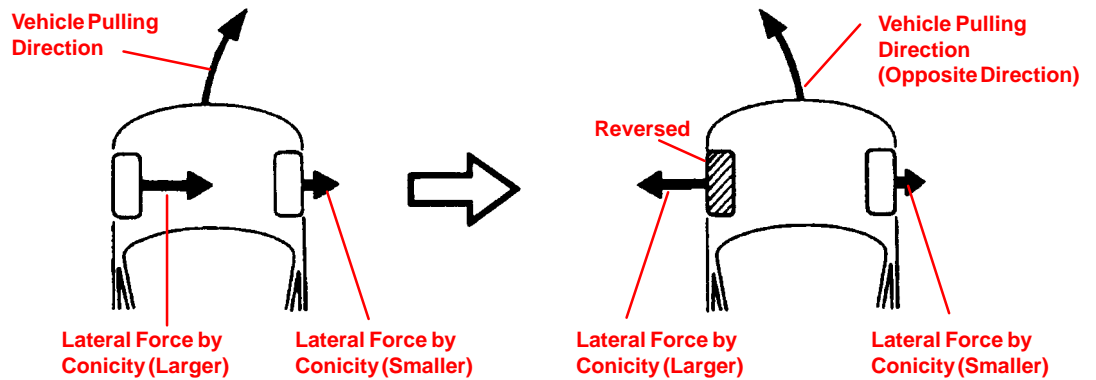
If Vehicle Pulls in the Opposite Direction: Go to STEP 2.

The lateral force generated by the left front tire is greater than the right tire, so the vehicle is pulling due to the lateral force of the left tire.

Rotate the **larger** lateral force front tire with the rear tire and check the change in the vehicle pulling.
