FRONT NO. 2 SPEAKER

ON-VEHICLE INSPECTION

REMOVAL

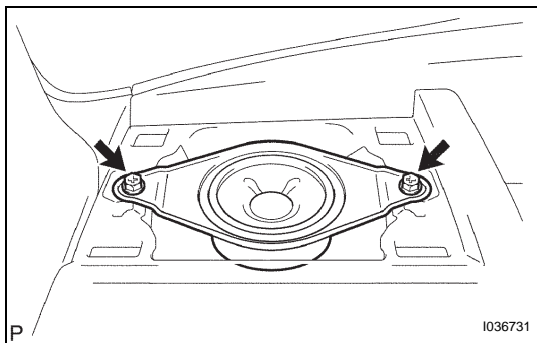
3. REMOVE NO. 2 FRONT SPEAKER ASSEMBLY LH

- (a) Remove the 2 bolts and speaker.
- (b) Disconnect the connector.
