DTC	B1187/55	Short to GND in Front Passenger Side Squib 2nd Step Circuit
-----	----------	--

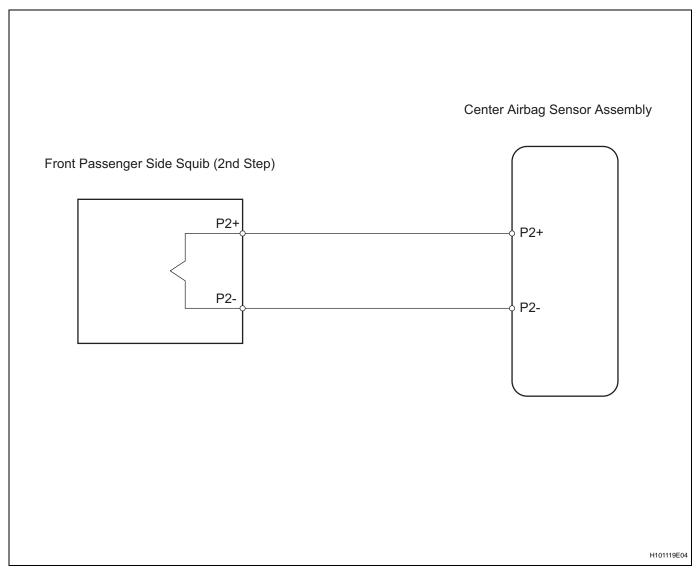
WIRING DIAGRAM

The front passenger side squib (2nd step) circuit consists of the center airbag assembly and the front passenger airbag assembly.

This circuit instructs the SRS to deploy when deployment conditions are met.

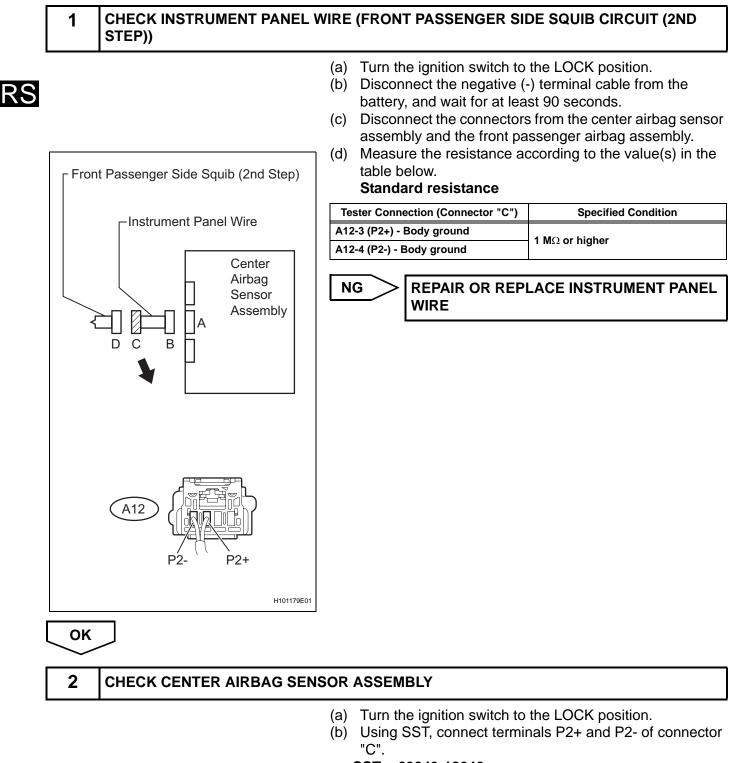
- SST 09843-18040
- NOTICE:

Do not forcibly insert SST into the terminals of the connector when connecting.
