Introduction On some ECHO, Scion xA, and Scion xB vehicles, a condition may exist that allows the evaporator drain hose to become detached, causing the passenger foot well to become wet. This bulletin provides a procedure to correct this condition.

- Applicable Vehicles**
- **2003 – 2005** model year **ECHO** vehicles produced **BEFORE** the Production Change Effective VIN shown below.
 - **2004 – 2006** model year **Scion xA** and **xB** vehicles produced **BEFORE** the Production Change Effective VINs shown below.

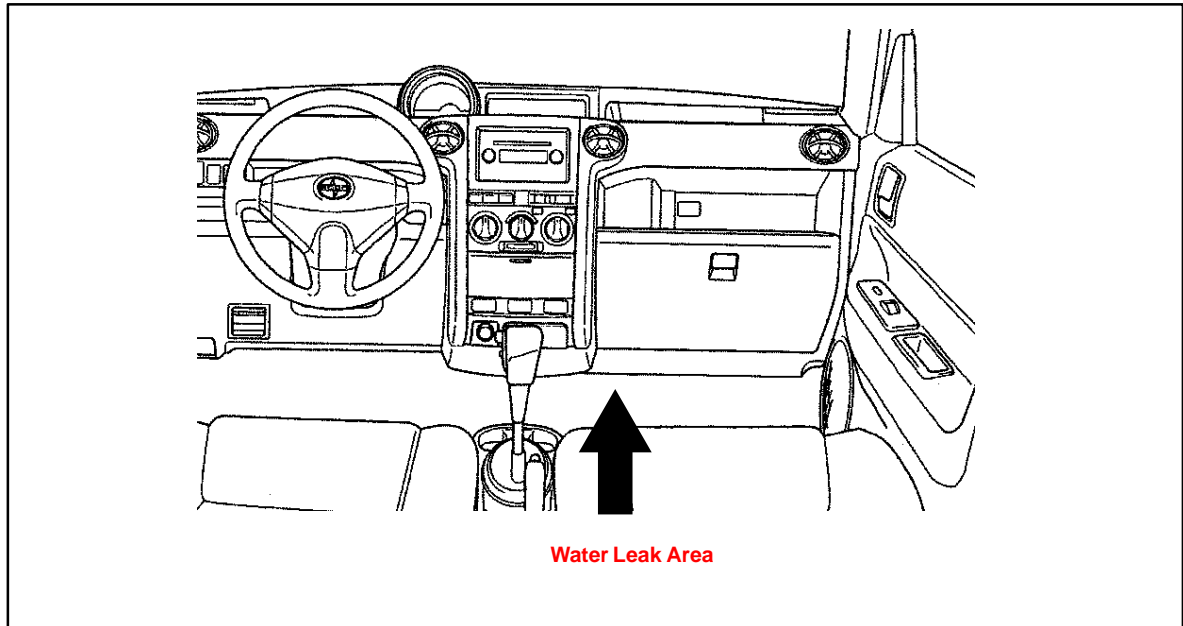
1. Inspect the evaporator drain hose to ensure that it is the cause of the water leak. If the evaporator hose is out of position, continue with this procedure.
