**Technical Service
BULLETIN**

**REPAIR MANUAL SUPPLEMENT:
VEHICLE PULLING TO ONE SIDE**

All '02 – '06 Toyota & '04 – '06 Scion Models

REVISÉD
ST005-01
STEERING

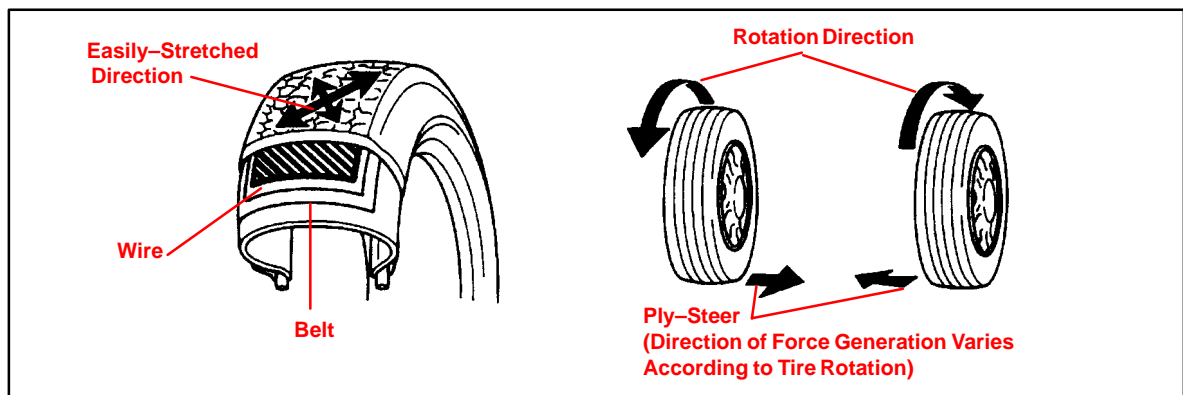
A. Ply–Steer

Lateral force due to ply–steer is produced by the construction of the belts inside the tire tread. With radial tires, the wire of the belt is slanted as shown in the illustration below. Thus, it is in the lateral direction that tire tread easily changes shape (stretches), and lateral force is generated between the tire and the road surface in the lateral direction.

Lateral force from ply–steer prevents vehicle drift caused by road slant, so in many cases lateral force to the left is provided to compensate for road slant to the right.

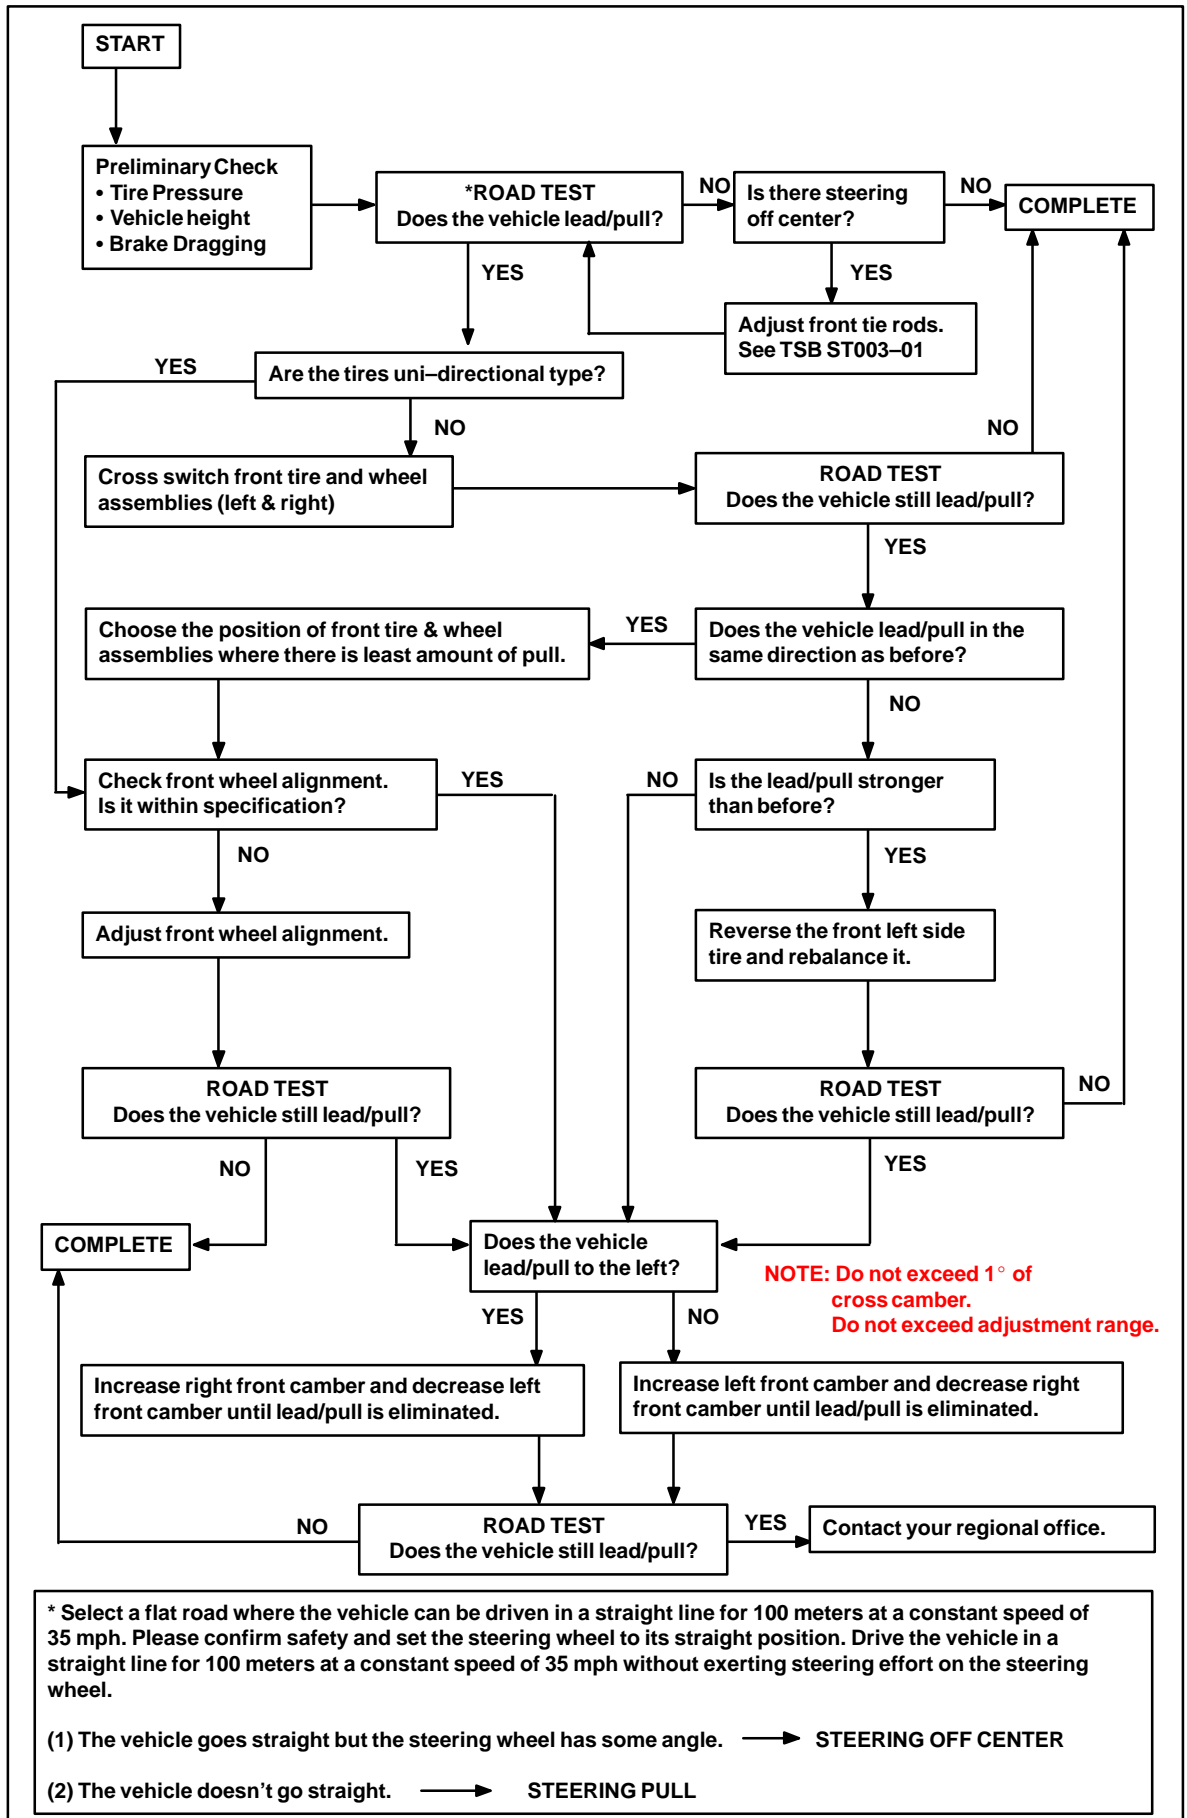
Repair Procedure Flow Chart

First determine whether vehicle pulling to one side is caused by a wheel alignment problem or tire characteristics, then decide which repairs to make.
