ON-VEHICLE INSPECTION

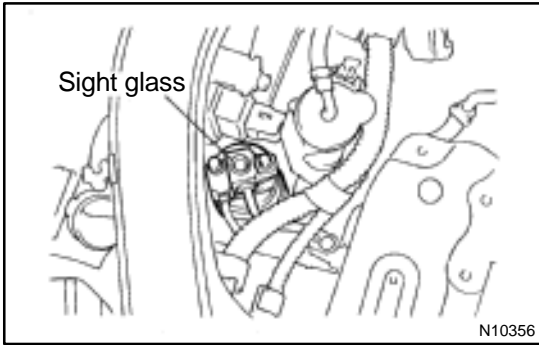
1. INSPECT REFRIGERANT VOLUME

Observe the sight glass on the liquid tube.

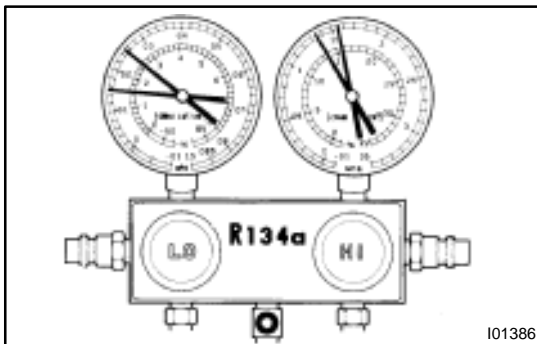
(1) Normally functioning refrigeration system.

Gauge reading:

Low pressure side:

0.15 – 0.25 MPa (1.5 – 2.5 kgf/cm²)

High pressure side:

1.37 – 1.57 MPa (14 – 16 kgf/cm²)

2. INSPECT REFRIGERANT PRESSURE WITH MANIFOLD GAUGE SET

This is a method in which the trouble is located by using a manifold gauge set. Read the manifold gauge pressure when the these conditions are established.

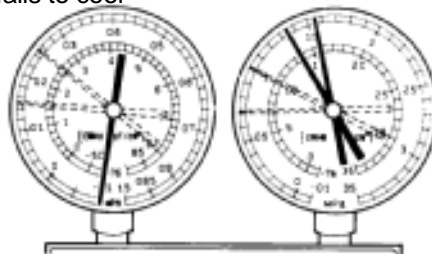
I01387

(2) Moisture present in refrigeration system.

Condition : Periodically cools and then fails to cool

| Symptom seen in refrigeration system | Probable cause | Diagnosis | Remedy |
|---|---|---|---|
| During operation, pressure on low pressure side sometimes become a vacuum and sometime normal | Moisture entered in refrigeration system freezes at expansion valve orifice and temporarily stops cycle, but normal state is restored after a time when the ice melts | <ul style="list-style-type: none"> • Drier in oversaturated state • Moisture in refrigeration system freezes at expansion valve orifice and blocks circulation of refrigerant | (1) Replace receiver (2) Remove moisture in cycle through repeatedly evacuating air (3) Charge proper amount of new refrigerant |

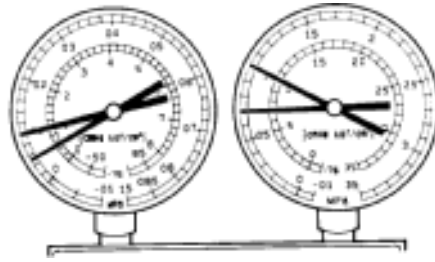
I01388

(3) Insufficient cooling

Condition: Insufficient cooling

| Symptom seen in refrigeration system | Probable cause | Diagnosis | Remedy |
|--|---|---|---|
| <ul style="list-style-type: none"> • Pressure low on both low and high pressure sides • Bubbles seen in sight glass continuously • Insufficient cooling performance | Gas leakage at some place in refrigeration system | <ul style="list-style-type: none"> • Insufficient refrigerant in system • Refrigerant leaking | <ol style="list-style-type: none"> (1) Check for gas leakage with gas leak detector and repair if necessary (2) Charge proper amount of refrigerant (3) If indicated pressure value is near 0 when connected to gauge, create the vacuum after inspecting and repairing the location of the leak |

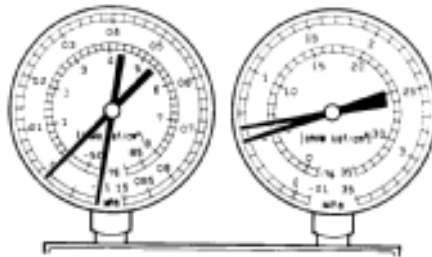
I01389

(4) Poor circulation of refrigerant

Condition: Insufficient cooling

| Symptom seen in refrigeration system | Probable cause | Diagnosis | Remedy |
|---|---|---|---|
| <ul style="list-style-type: none"> • Pressure low in both low and high pressure sides • Frost on tube from receiver to unit | Refrigerant flow obstructed by dirt in receiver | Receiver clogged | Replace receiver |

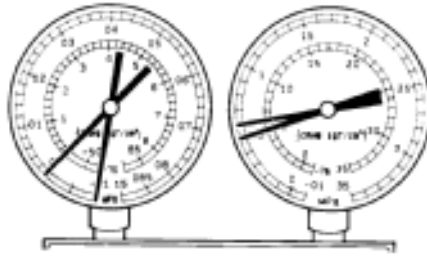
I01449

(5) Refrigerant does not circulate

Condition: Does not cool (Cools from time to time in some cases)

| Symptom seen in refrigeration system | Probable cause | Diagnosis | Remedy |
|---|--|---|---|
| <ul style="list-style-type: none"> • Vacuum indicated on low pressure side, very low pressure indicated on high pressure side • Frost or dew seen on piping before and after receiver/ drier or expansion valve | <ul style="list-style-type: none"> • Refrigerant flow obstructed by moisture or dirt in refrigeration system • Refrigerant flow obstructed by gas leakage from expansion valve | Refrigerant does not circulate | <ol style="list-style-type: none"> (1) Check expansion valve (2) Clean out dirt in expansion valve by blowing with air (3) Replace receiver (4) Evacuate air and charge new refrigerant to proper amount (5) For gas leakage from expansion valve, replace expansion valve |

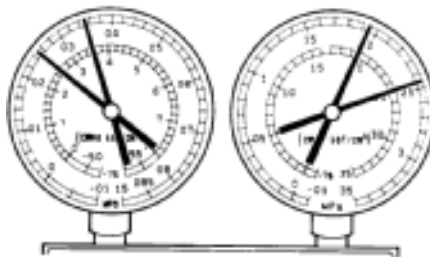
I01390

(6) Refrigerant overcharged or insufficient cooling of condenser

Condition: Insufficient cooling

| Symptom seen in refrigeration system | Probable cause | Diagnosis | Remedy |
|--|--|---|--|
| <ul style="list-style-type: none"> • Pressure too high on both low and high pressure sides • No air bubbles seen through the sight glass even when the engine rpm is lowered | <ul style="list-style-type: none"> • Unable to develop sufficient performance due to excessive • Insufficient cooling of condenser | <ul style="list-style-type: none"> • Excessive refrigerant in cycle → refrigerant overcharged • Condenser cooling insufficient → condenser fins clogged or cooling fan faulty | <ol style="list-style-type: none"> (1) Clean condenser (2) Check cooling fan with fluid coupling operation (3) If (1) and (2) are in normal state, check amount of refrigerant. Charge proper amount of refrigerant |

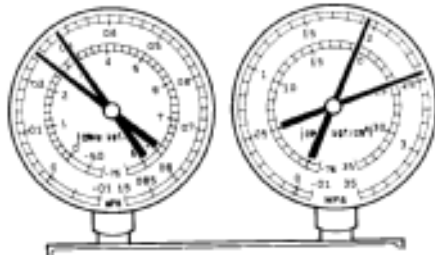
I01392

(7) Air present in refrigeration system

Condition: Insufficient cooling

NOTE : These gauge indications are shown when the refrigeration system has been opened and the refrigerant charged without vacuum purging.

| Symptom seen in refrigeration system | Probable cause | Diagnosis | Remedy |
|--|---|--|---|
| <ul style="list-style-type: none"> • Pressure too high on both low and high pressure sides • The low pressure piping hot to the touch • Bubbles seen in sight glass | Air entered in refrigeration system | <ul style="list-style-type: none"> • Air present in refrigeration system • Insufficient vacuum purging | (1) Check compressor oil to see if it is dirty or insufficient (2) Evacuate air and charge new refrigerant |

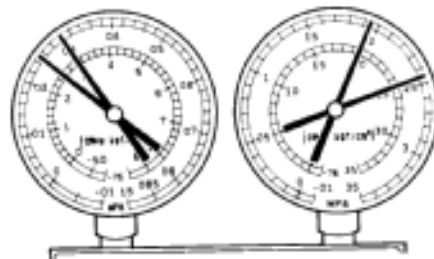
I01450

(8) Expansion valve improperly

Condition: Insufficient cooling

| Symptom seen in refrigeration system | Probable cause | Diagnosis | Remedy |
|--|---|---|---|
| <ul style="list-style-type: none"> • Pressure too high on both low and high pressure sides • Frost or large amount of dew on piping on low pressure side | Trouble in expansion valve | <ul style="list-style-type: none"> • Excessive refrigerant in low pressure piping • Expansion valve opened too wide | Check expansion valve Replace if defective |

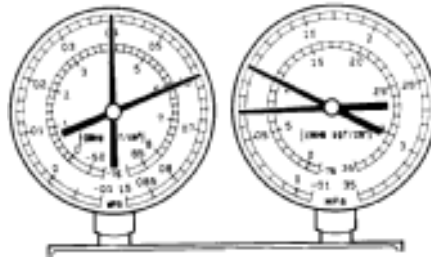
I01393

(9) Defective compression compressor

Condition : Does not cool

| Symptom seen in refrigeration system | Probable cause | Diagnosis | Remedy |
|---|---|--|---|
| <ul style="list-style-type: none"> • Pressure too high on low high pressure sides • Pressure too low to on high pressure side | Internal leak in compressor | <ul style="list-style-type: none"> • Compression defective • Valve leaking or broken sliding parts | Repair or replace compressor |

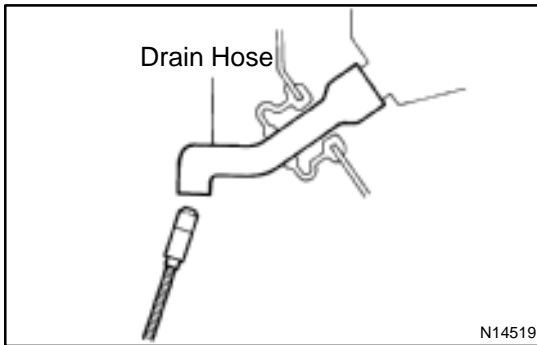
- (b) Bring the gas leak detector close to the drain hose before performing the test.

- After the blower motor stopped, leave the cooling unit for more than 15 minutes.
- Expose the gas leak detector sensor the under the drain hose.
- When bring the gas leak detector close to the drain hose, make sure that the gas leak detector does not react to the volatile gases.

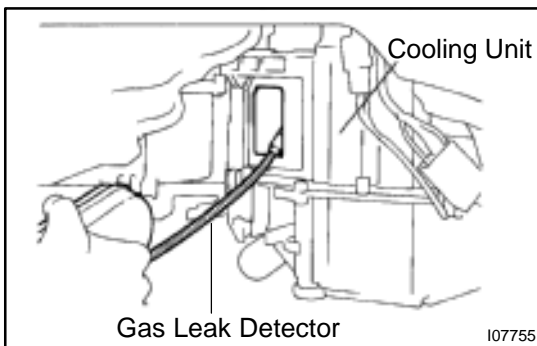
- (c) If gas leak is not detected on the drain hose, remove the blower resistor from the cooling unit. Then insert the gas leak detector sensor into the unit and perform the test.

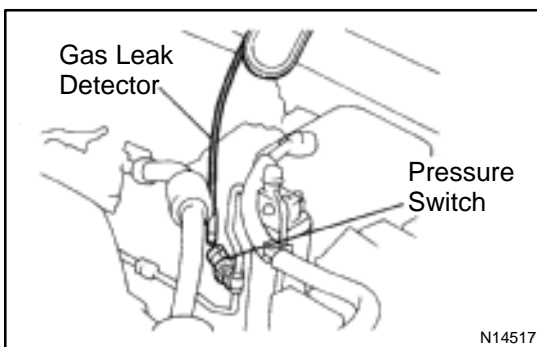
- (d) Disconnect the connector and leave the pressure switch for approx. 20 minutes. Then bring the gas leak detector close to the pressure switch and perform the test.
- (e) Bring the gas leak detector close to the refrigerant lines and perform the test.
