# Driver Side Seat Belt Warning Light does not Operate

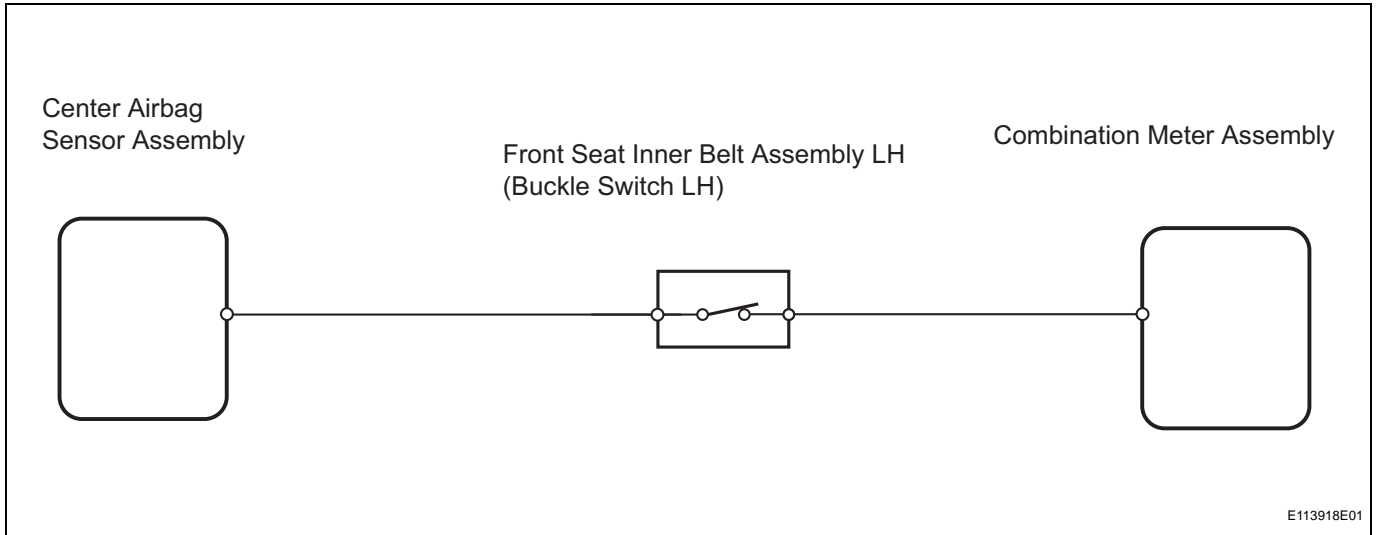
E113918E01

## WIRING DIAGRAM

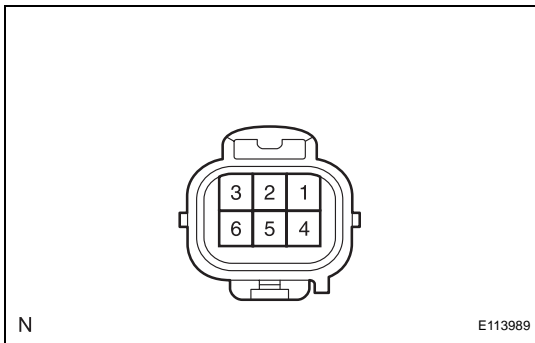
E113989

### 1 INSPECT FRONT SEAT INNER BELT ASSEMBLY LH (BUCKLE SWITCH LH)

- (a) Disconnect the B7 belt connector.
- (b) Measure the resistance of the connector.

#### Standard resistance

Tester Connection	Switch Condition	Specified Condition
1 - 3	Driver side seat belt is fastened (buckle switch ON)	1,200 to 1,460 Ω
	Driver side seat belt is unfastened (buckle switch OFF)	300 to 360 Ω

REPLACE FRONT SEAT INNER BELT ASSEMBLY LH

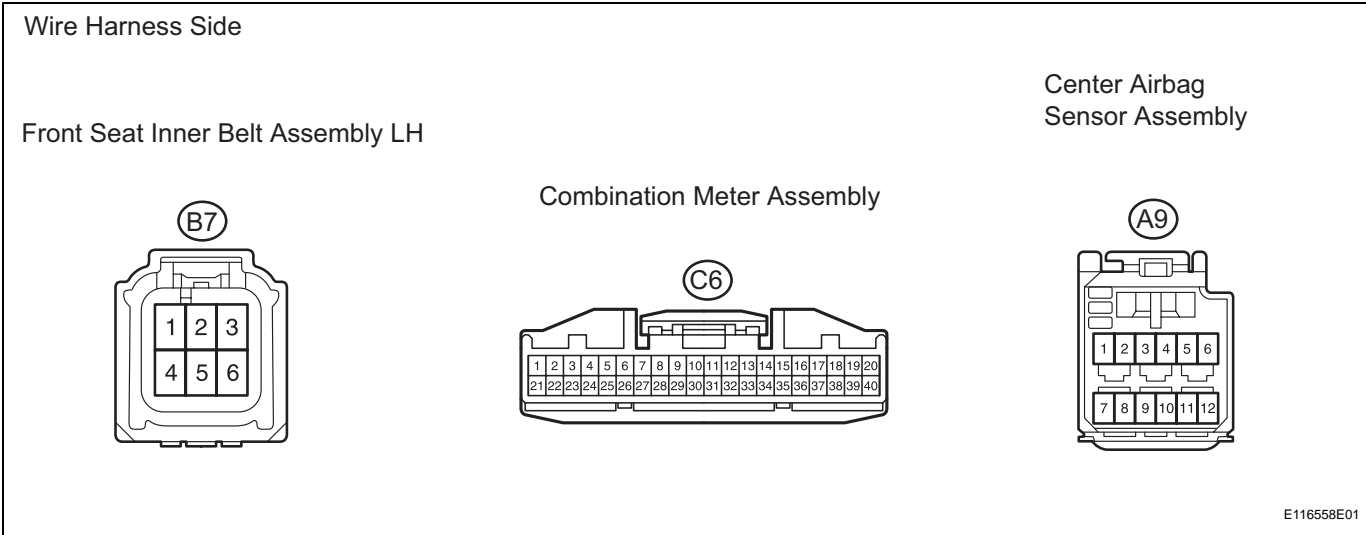
**2 CHECK WIRE HARNESS (SEAT INNER BELT - COMBINATION METER AND AIRBAG SENSOR)**

- (a) Disconnect the B7 belt connector.
- (b) Disconnect the C6 meter connector.
- (c) Disconnect the A9 sensor connector.
- (d) Measure the resistance of the connectors.

**Standard resistance**

Tester Connection	Specified Condition
B7-3 - C6-32	Below 1 Ω
B7-1 - A9-7

**NG** → **REPAIR OR REPLACE HARNESS AND CONNECTOR**

**REPLACE COMBINATION METER ASSEMBLY**
