DTC	B0138/72	Short to B+ in Front Pretensioner Squib LH Cir- cuit
-----	----------	---

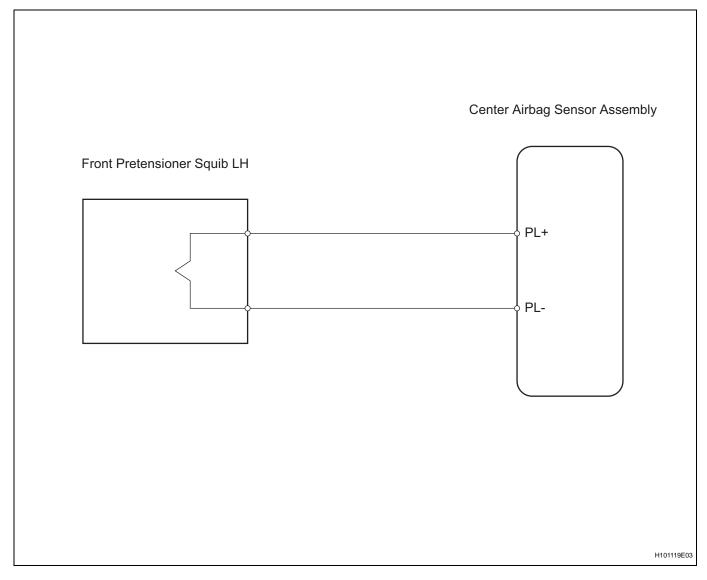
## WIRING DIAGRAM

The front pretensioner LH circuit consists of the center airbag sensor assembly and the front seat outer belt assembly (seat belt pretensioner LH).

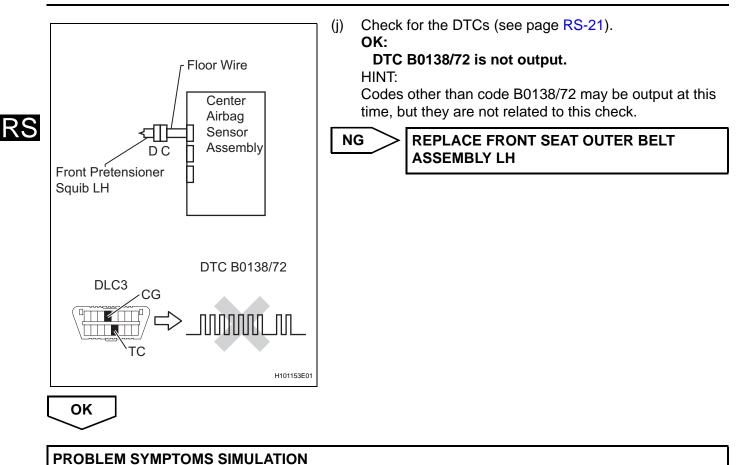
## CHECK FRONT SEAT OUTER BELT ASSEMBLY LH

- (a) Turn the ignition switch to the LOCK position.
- (b) Disconnect the negative (-) terminal cable from the battery, and wait for at least 90 seconds.
- (c) Disconnect the service wire from the connector "C".
- (d) Connect the connector to the front seat outer belt assembly LH.
- (e) Connect the negative (-) terminal cable to the battery, and wait for at least 2 seconds.
- (f) Turn the ignition switch to the ON position, and wait at least 60 seconds.
- (g) Clear the stored in the memory (see page RS-21).
- (h) Turn the ignition switch LOCK position.
- (i) Turn the ignition switch ON position, and wait for at least 60 seconds.
